Original Research Article

Management and Treatment of Trochanteric Fracture -A Novel Factor of Intramedullary Nail Failure

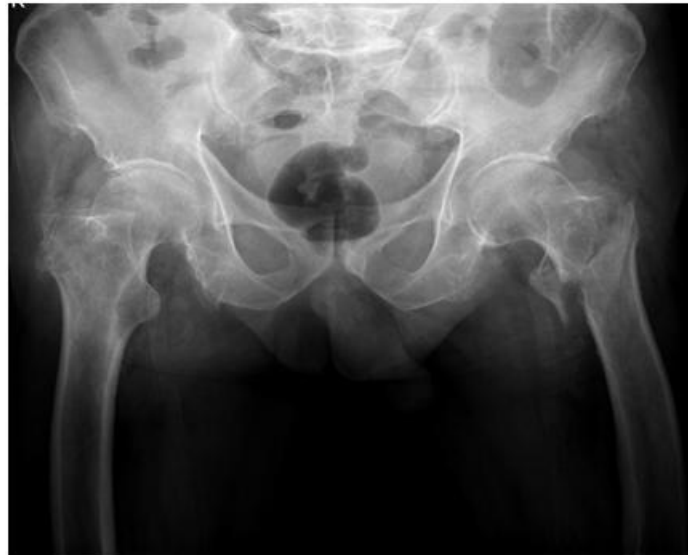
Figure 2. Radiography showing left pertrochanteric fracture

increased bone fragility, falls from the same level or in some patients either cardiac either psychiatric pathology (Grigorie et al., 2019). Figure 2

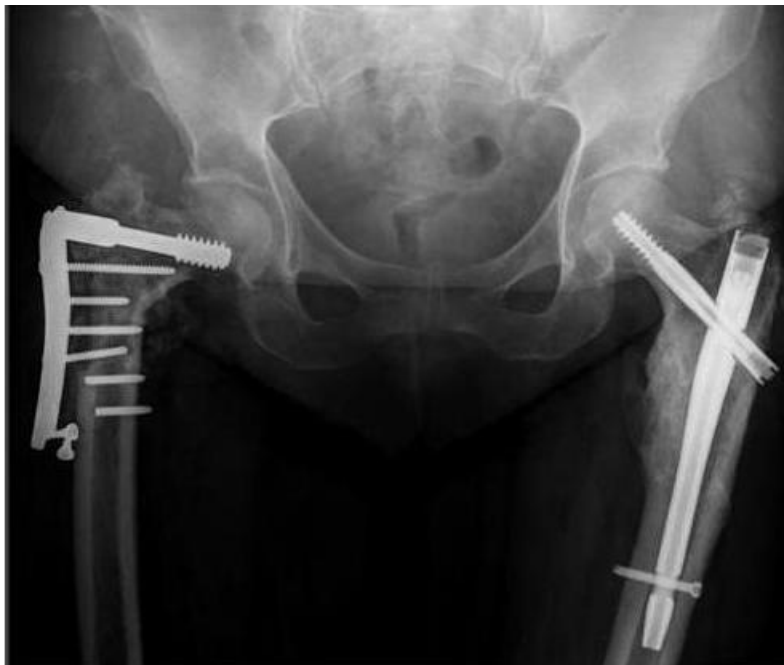
Figure 3. Before right hip surgery

The second aspect of this study is a patient, with bilateral hip fractures (approx. 2 years distance between fractures), operated in another emergency clinic with a DCS system. We changed the implant with an intramedullary nail. The right hip is of interest for this research. We applied the same method, but this time the nail broke after 6 months. Screw position was optimal. The insufficient restore of lateral femoral cortical bone was identified as the cause. The stress shielding forces were high and the bone healing was incomplete. The nail broke in the proximal part. A good solution was bone grafting and a longer nail. The same screw position was used, second time. Pain levels were low and the patient was able to walk. No follow-up was possible. (Figure 3,4)

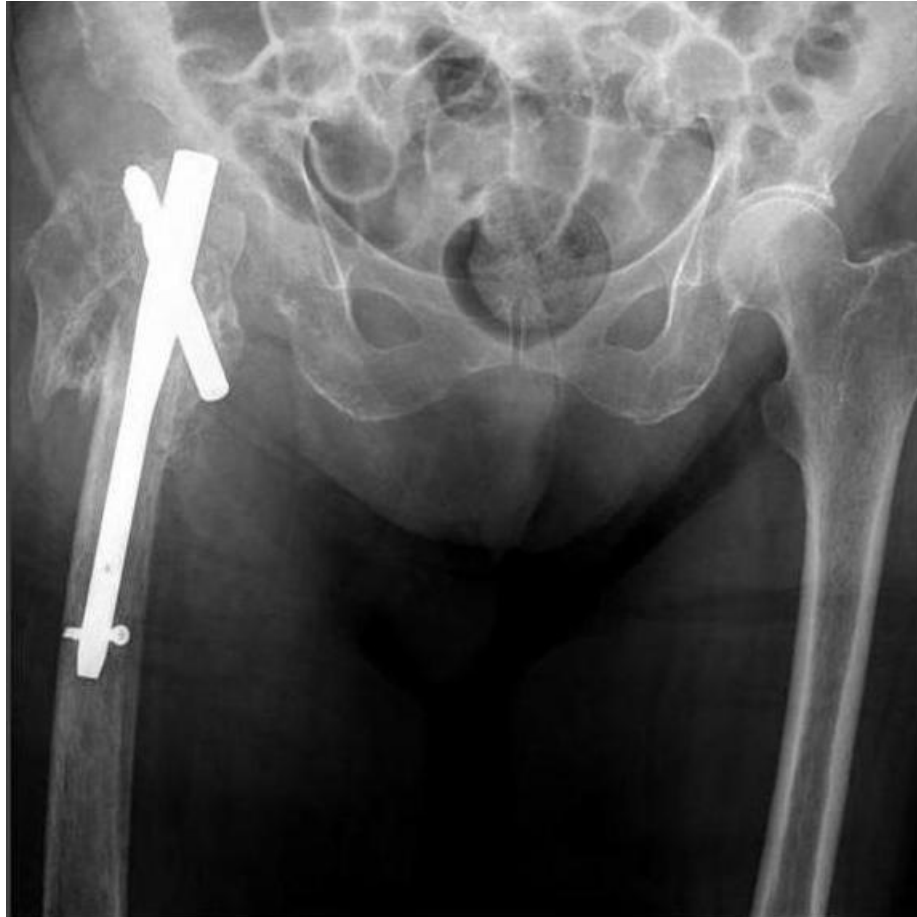
Figure 7. 83y patient, operated in another hospital, presented at our emergency room with local sepsis signs and major misplacement of the implant.

The last case, was an extremely misplaced implant with associated severe sepsis and non-union. Figure 7,8: In this particular case, there was a drastic error in the reduction of the fracture, associated with life threatening comorbidities.

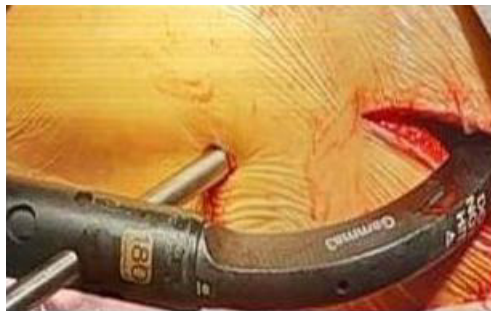
Figure 9. Nail guiding system

Checking the guide for the for the lag screw, we identified an average of 1.4mm error, from 10 tests. The cause for this error was the locking hex screw that locks the guide to the nail and also the threaded kirschner wire, used as a guide. That allows for small errors at the passing of the lag-screw through the nail. Small scratches on the coating and inside the nail's hole were observed.

This finding leads us to further investigate the broken implant, after extraction. On a microscopic view, we noticed small cracks and dents produced by the lag screw in the nail's hole. Titanium is an extremely stiff material, resilient to bending. Since its properties, it tends to increase stress shielding at the level of the fracture. Small scratches in the weakest point of the nail can determine a decrease in resistance. In this particular case, this was the second surgery, so bone healing was slower. Could small errors in the guiding system cause a decrease of the nail resistance? We identified up to 1.4mm of error in the system guiding instruments tray, caused by multiple use and maybe also inadequate. Figure 9

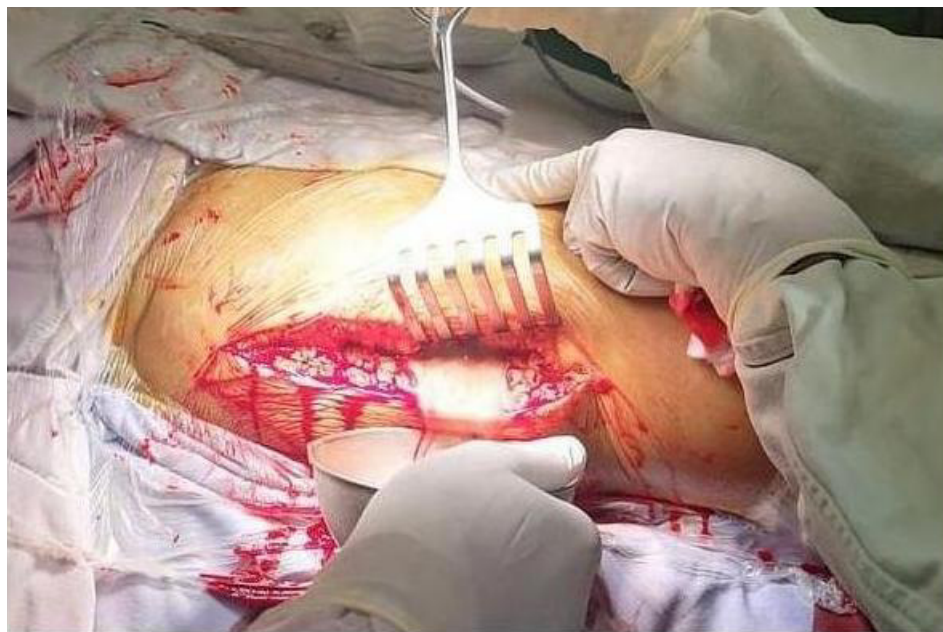
Figure 10. High quantity of pus in the hip region.

in our emergency room with clinical sepsis, with a malpositioned nail, without fracture reduction, after 8 months surgery in another hospital. She did not address another hospital service and no follow-up info was available during this period of time. Septic signs appeared one month before presenting in our clinic (family anamnesis, patient was semicomatose). At the clinical exam we identified a right shoulder arthritis. Since the patient's status was rapidly declining, we decided to perform extraction of the implant and debridement. Unfortunately, during surgery, the patient went into septic shock. Figure 10
